AIR HANDLING UNIT REFURBISHMENT

MORRISONS - PERTH
case study

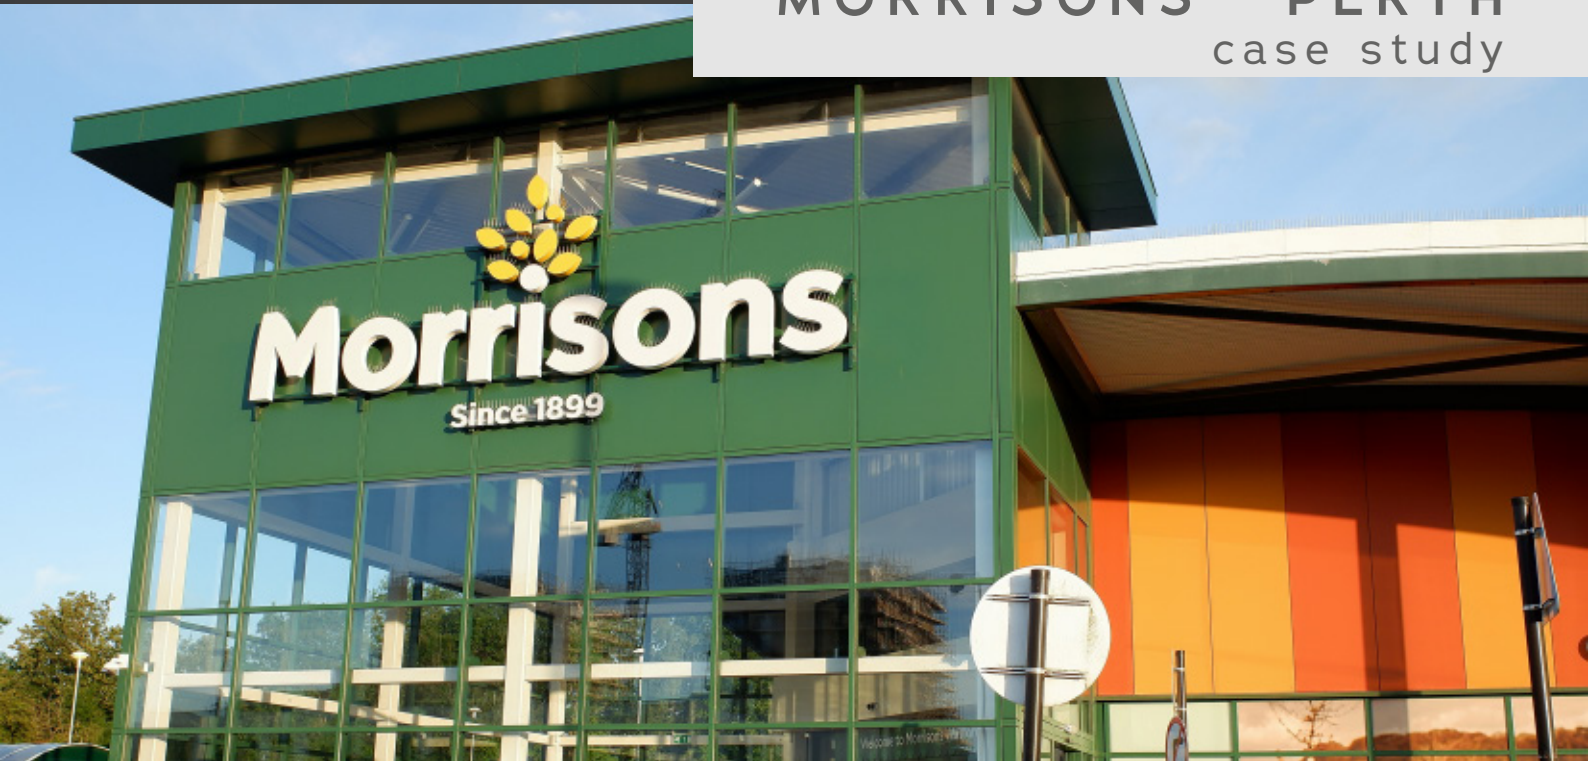
Upon inspection, the existing belt driven fan had suffered catastrophic damage due to the shaft shearing completely from the impeller. More critically, with the **9m³/s AHU** being completely out of service, this prevented the supply of any heated air across the main store shopping aisles, **significantly impacting customer and staff** comfort levels.

Due to the size of the existing fan, a like for like replacement would require a split casing and involve costly lifting equipment to allow the fan to be assembled in position. The innovative solution was to replace the existing belt driven fan and motor with a **FAN WALL** of **ULTRA-HIGH EFFICIENCY**, direct drive EC. plug fans.
