Morrisons Perth

Commercial Case Study

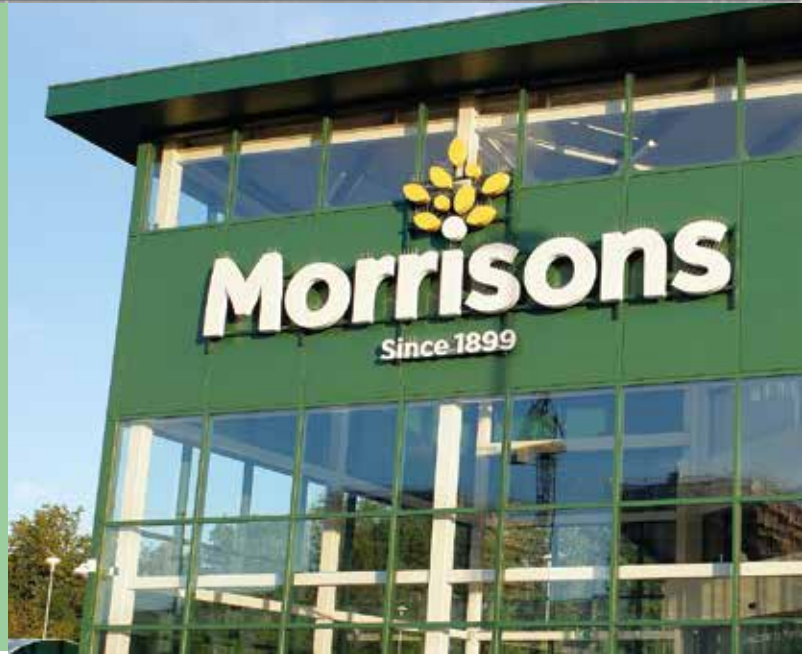
Upon inspection, the existing belt driven fan had suffered catastrophic damage due to the shaft shearing completely from the impeller. More critically, with the 9m³/s AHU being completely out of service, this prevented the supply of any heated air across the main store shopping aisles, significantly impacting customer and staff comfort levels.

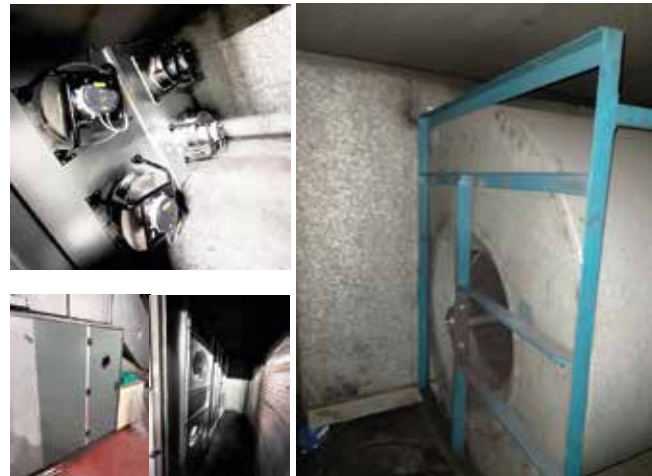
Due to the size of the existing fan, a like for like replacement would require a split casing and involve costly lifting equipment to allow the fan to be assembled in position. The innovative solution was to replace the existing belt driven fan and motor with a FAN WALL of ultra-high efficiency, direct drive EC. plug fans.

- ✓ **Improved reliability**
EC fans are direct driven which means no belts and pulleys.
- ✓ **Effective redundancy**
If one of the four EC fans were to fail, the remaining fans can continue to operate to provide airflow.
- ✓ **Future Proofing**
Eliminates multiple points of failure such as belts, pulleys, and bearings becoming faulty.
- ✓ **Reduced Maintenance**
Lightweight and compact for easier maneuverability and reduced maintenance requirements.
