## Morrisons Perth

Commercial  
Case Study

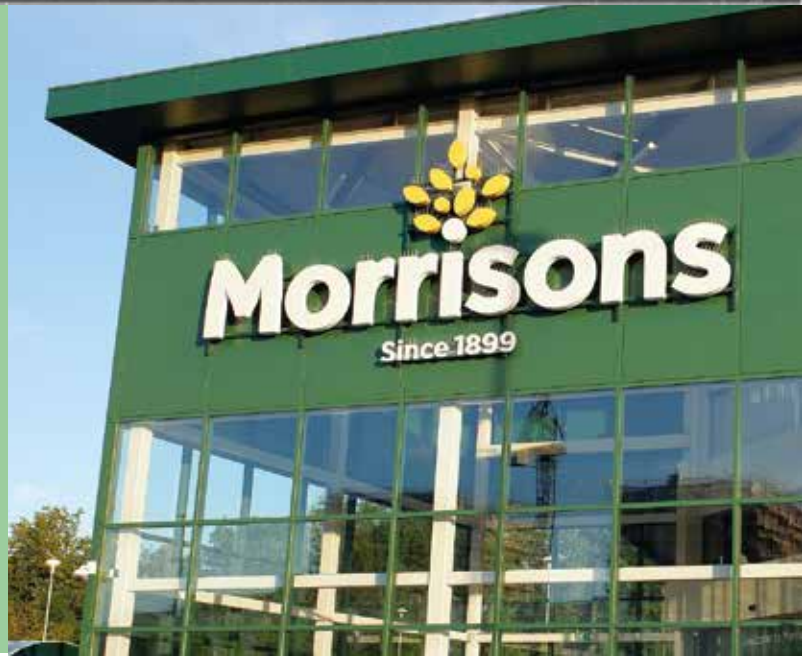
Upon inspection, the existing belt driven fan had suffered catastrophic damage due to the shaft shearing completely from the impeller. More critically, with the 9m<sup>3</sup>/s AHU being completely out of service, this prevented the supply of any heated air across the main store shopping aisles, significantly impacting customer and staff comfort levels.

Due to the size of the existing fan, a like for like replacement would require a split casing and involve costly lifting equipment to allow the fan to be assembled in position. The innovative solution was to replace the existing belt driven fan and motor with a FAN WALL of ultra-high efficiency, direct drive EC. plug fans.
